March 12, 2021

**Re: Seawall Inspection Report for Trailer Estates Park & Recreation
2303 Pennsylvania Ave, Bradenton, FL 34207**

MARINE ENGINEERING

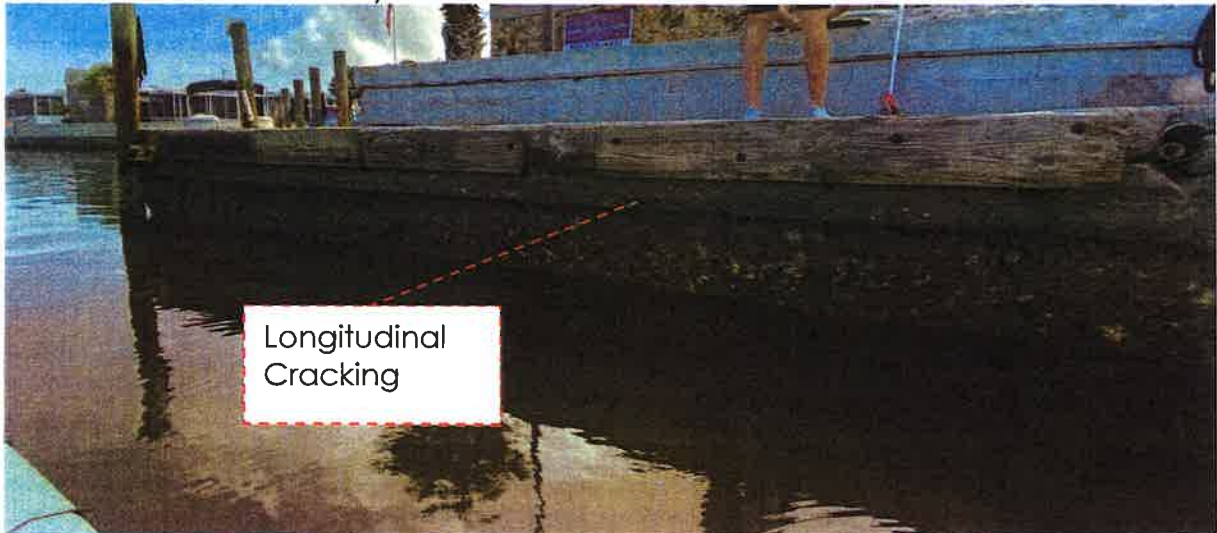
Photo #1- View of Wall by Marina.

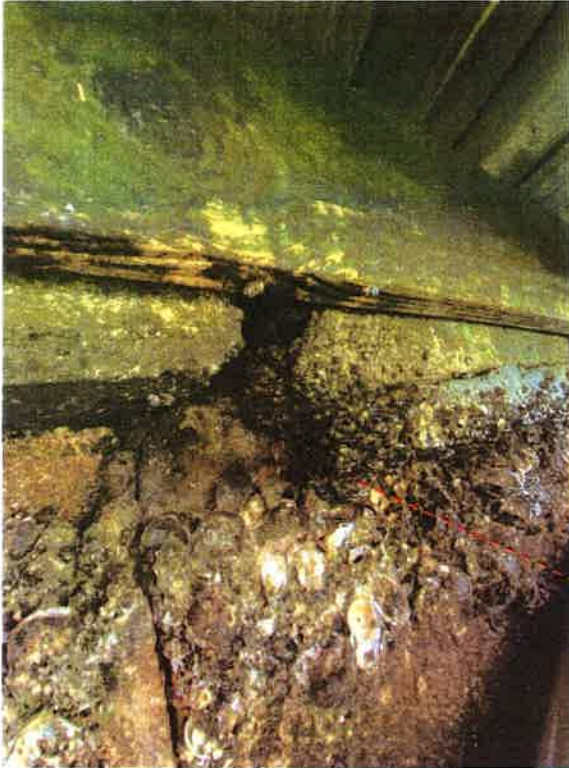
Photo #2 – View of Wall Under Dock at Marina Point.

Vertical Cracking
and Spalling

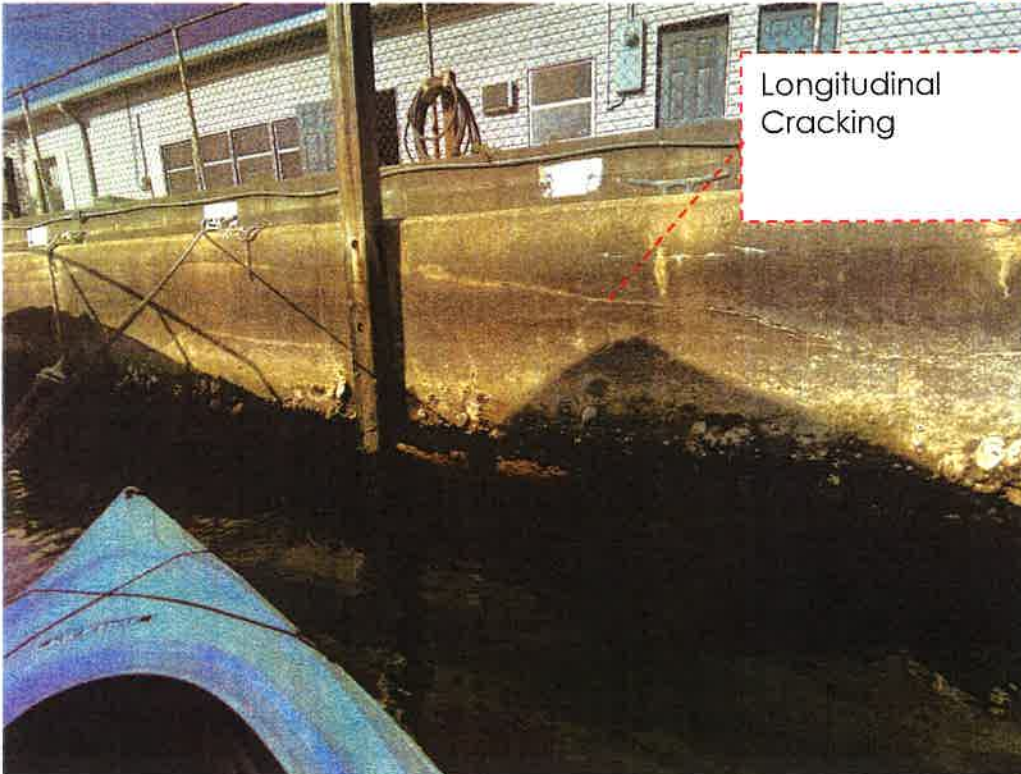
Photo #3- View of West Wall.

Longitudinal
Cracking

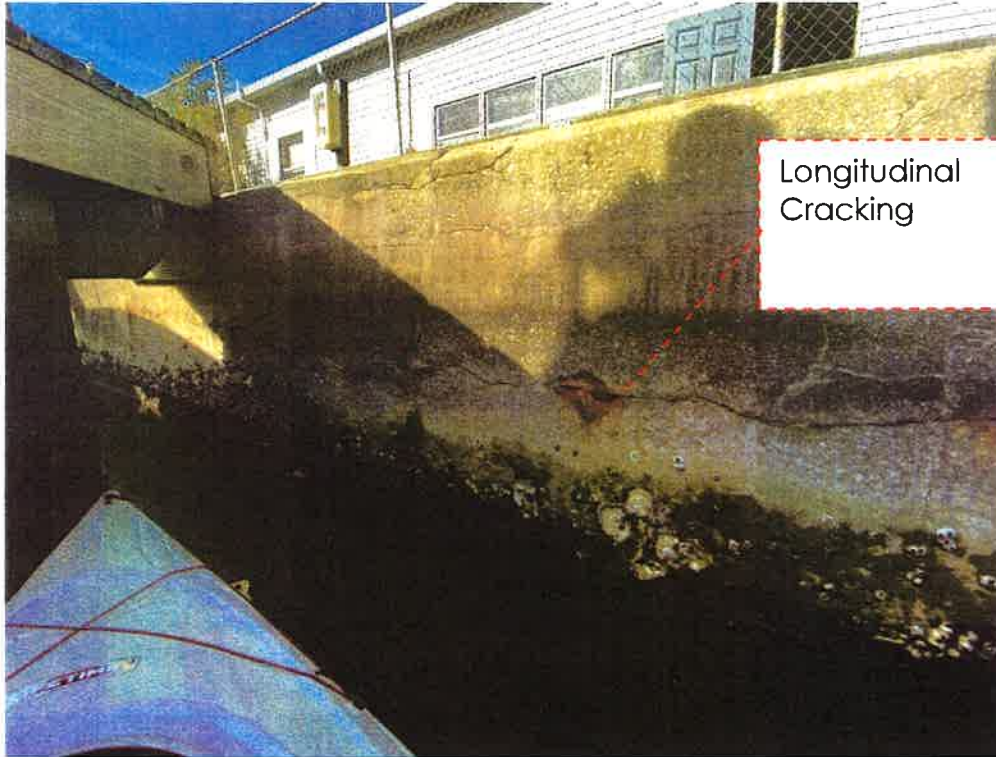
Photo #4- View of West Wall.

Longitudinal
Cracking

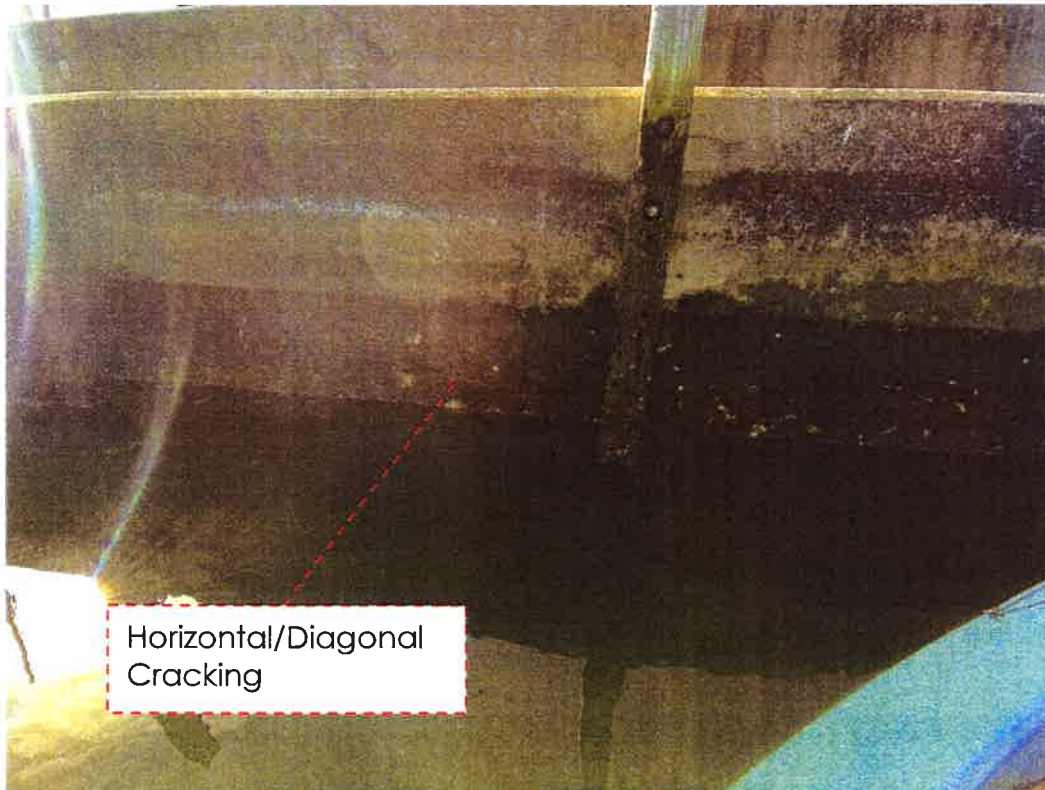
Photo #5- View of South Wall.

Horizontal/Diagonal
Cracking

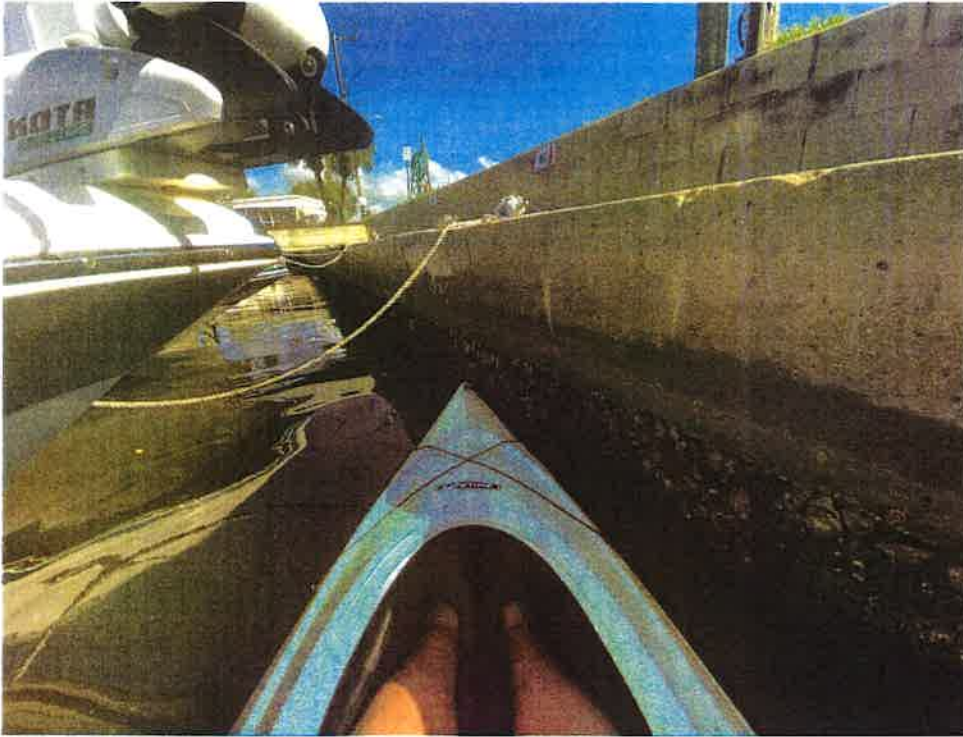
Photo #6- View of East Wall.

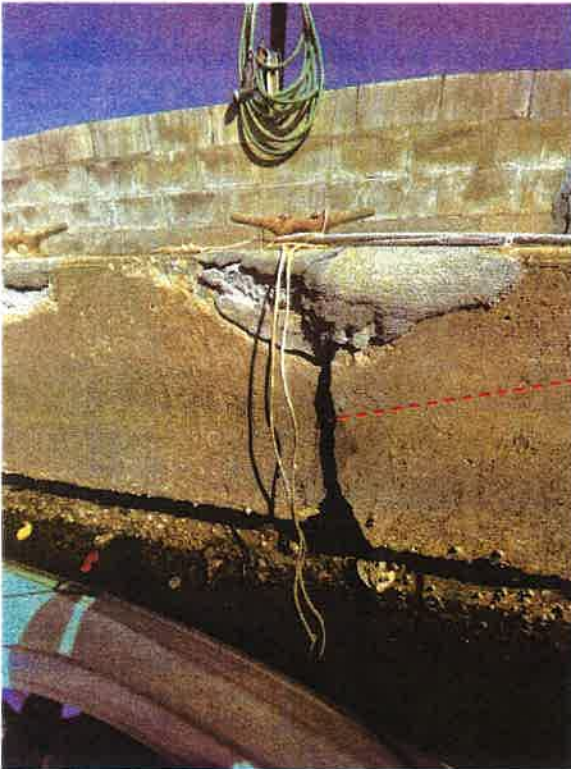
Photo #7- View of North Wall.

Vertical Cracking
and Spalling

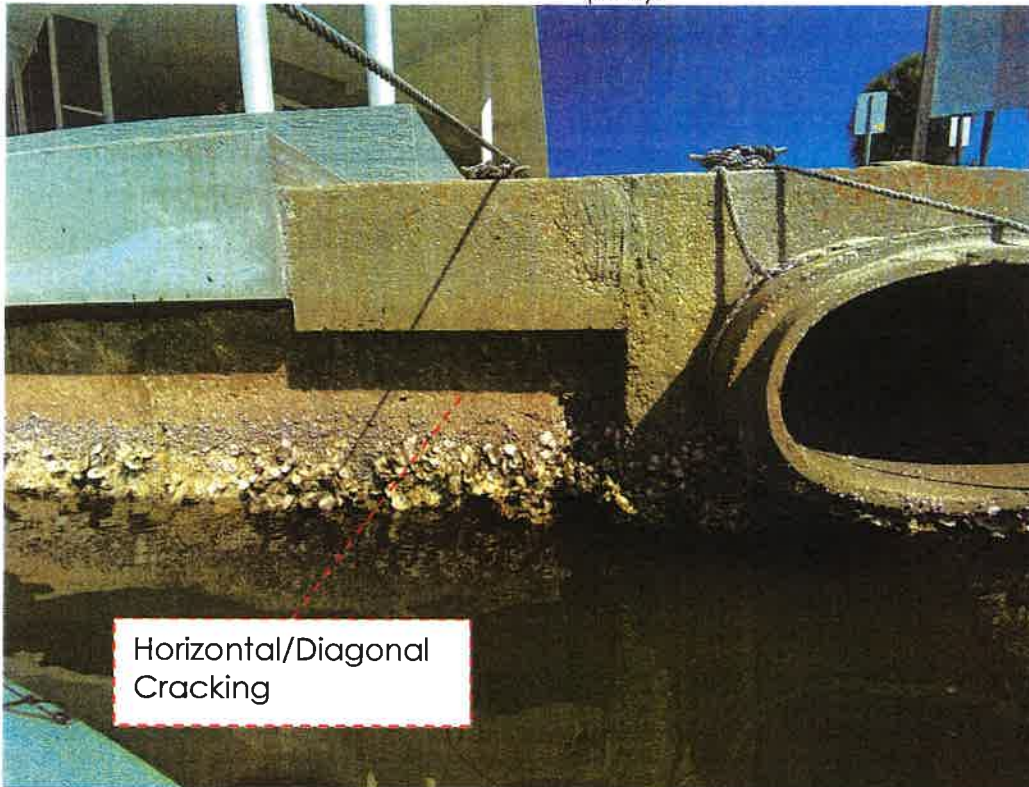
Photo #8 – View of North Wall at End of Property.

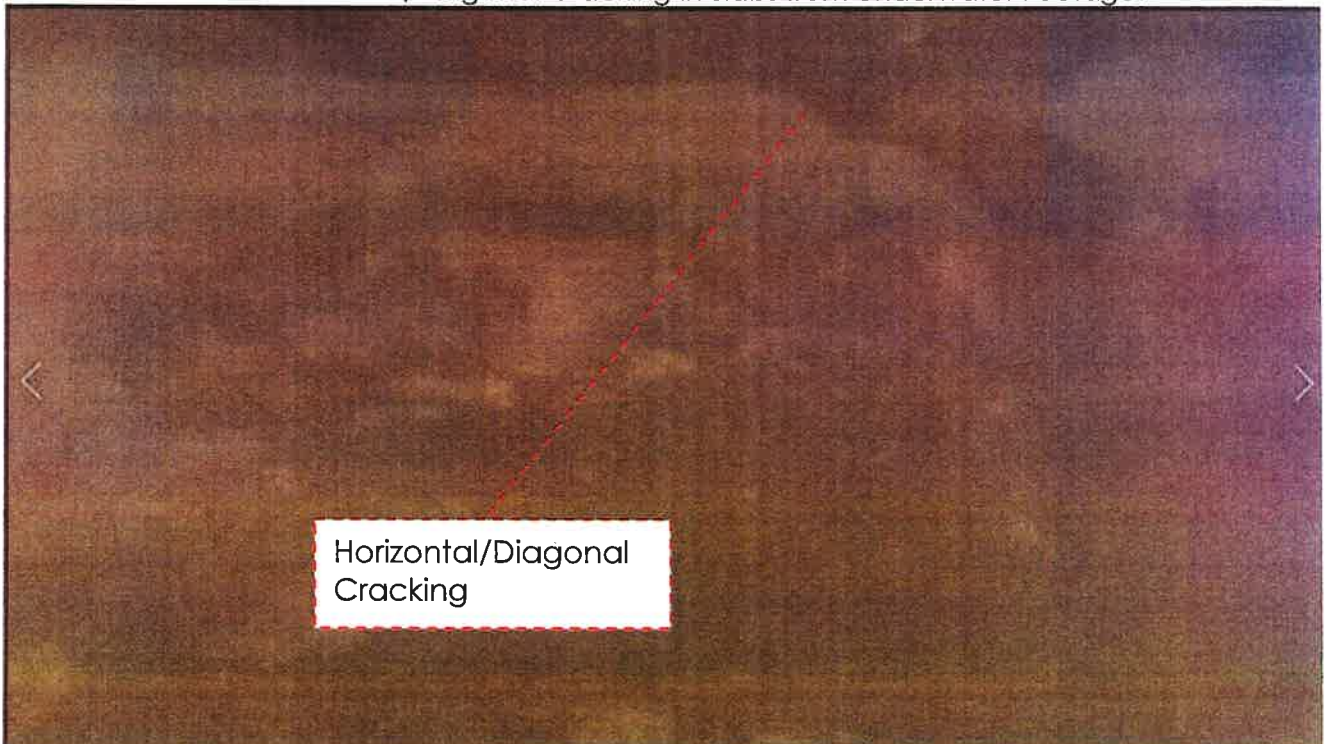
Photo #9- View of Horizontal/Diagonal Cracking in Slabs from Underwater Footage.

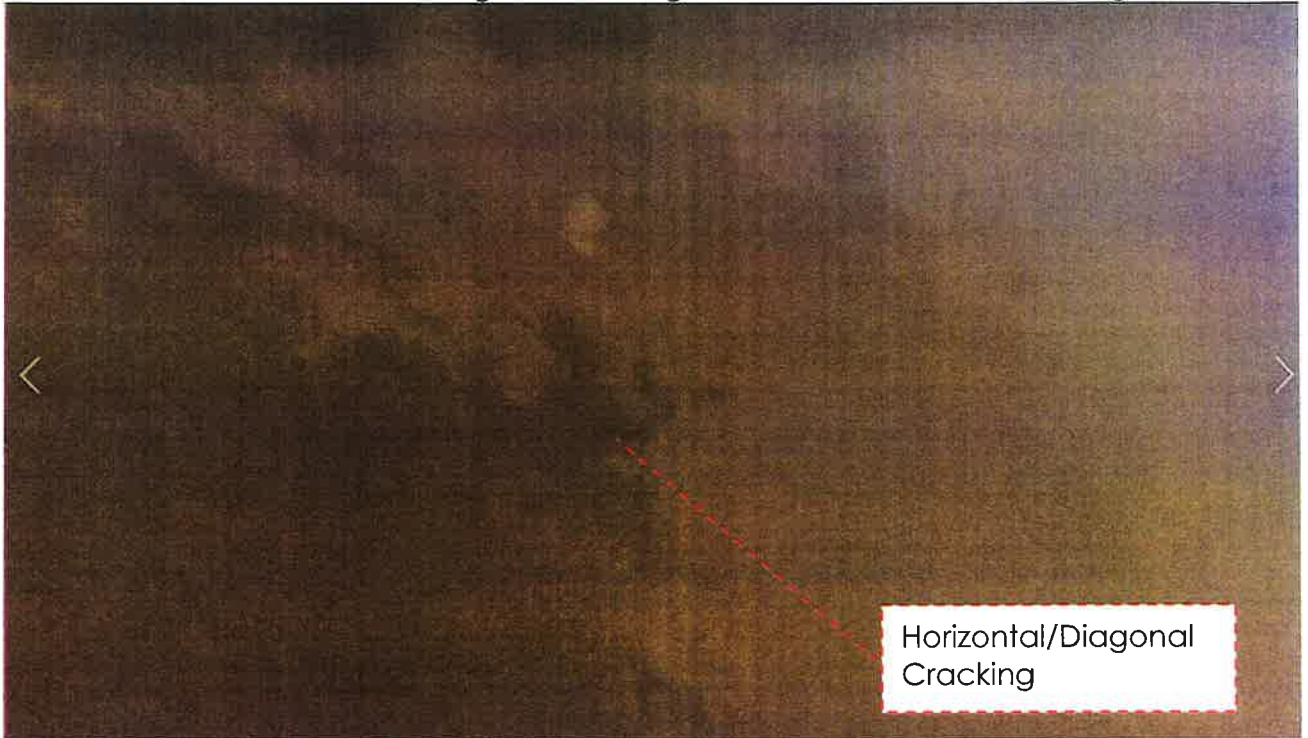
Photo #10- View of Horizontal/Diagonal Cracking in Slabs from Underwater Footage.

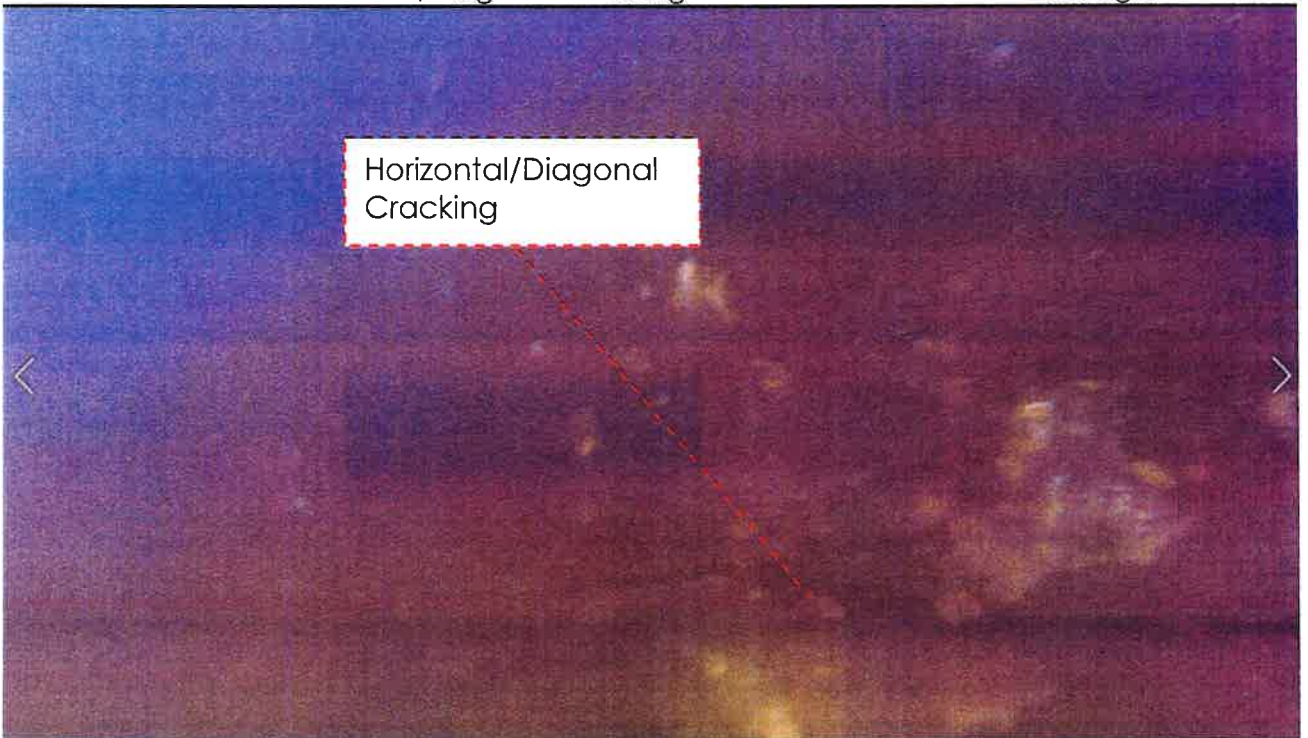
Photo #11- View of Horizontal/Diagonal Cracking in Slabs from Underwater Footage.

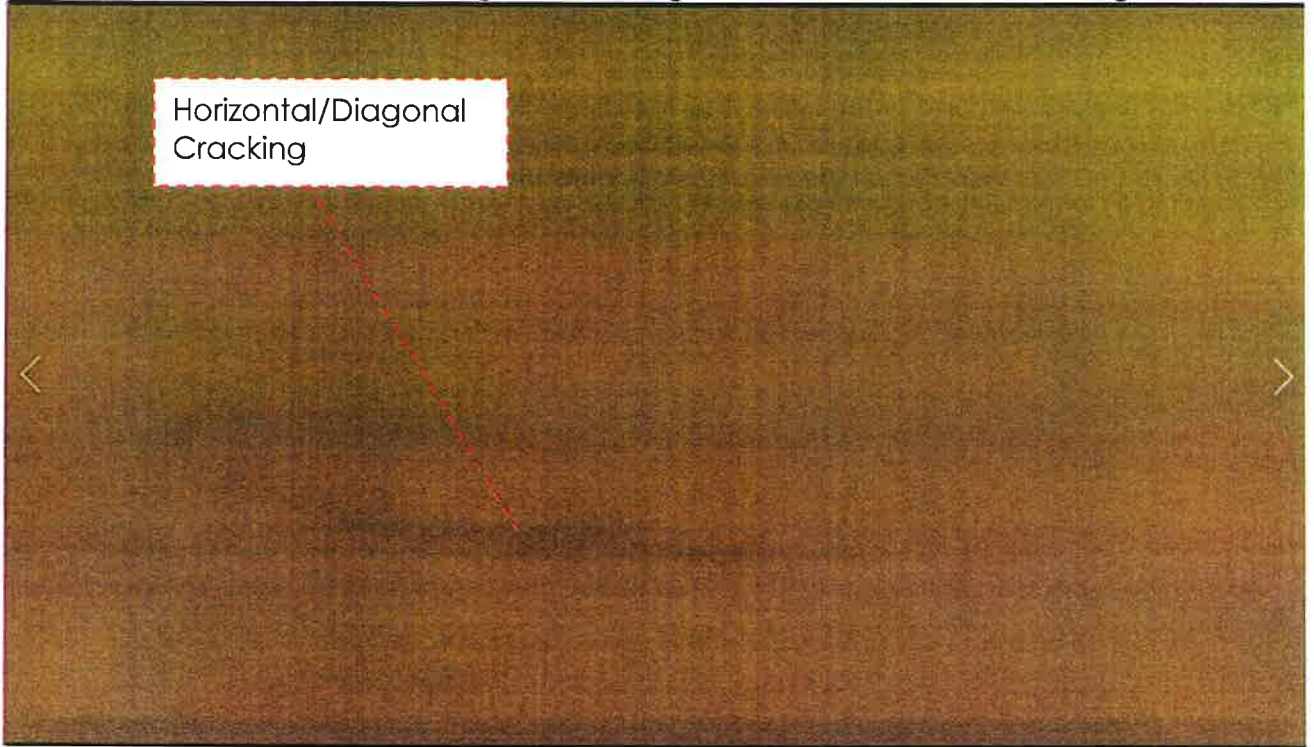
Photo #12- View of Horizontal/Diagonal Cracking in Slabs from Underwater Footage.
