March 12, 2021

**Re: Seawall Inspection Report for Trailer Estates Park & Recreation
2303 Pennsylvania Ave, Bradenton, FL 34207**

MARINE ENGINEERING

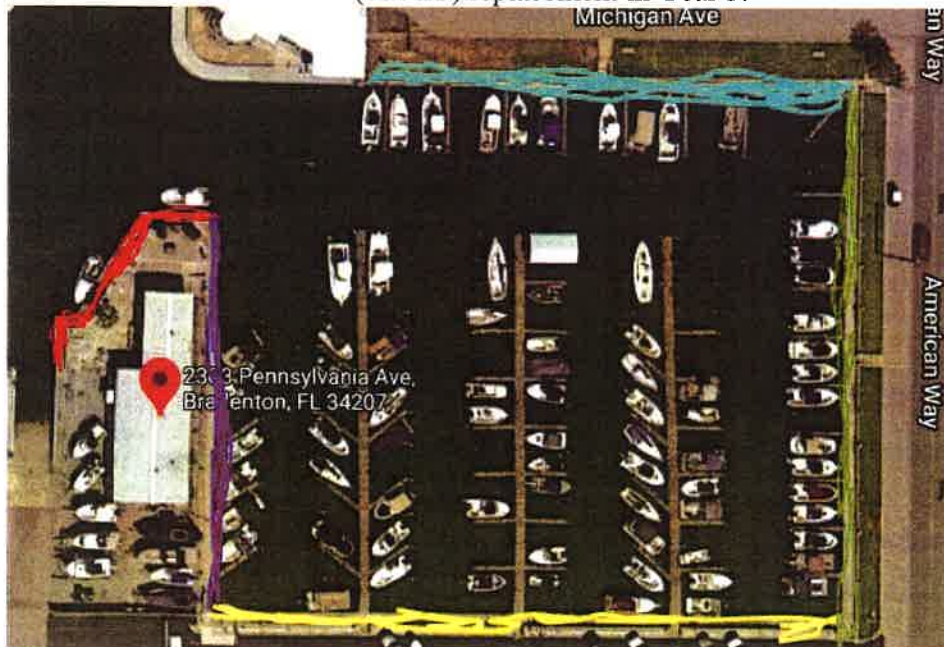
1. Phase 1 - South Wall (293 LF) replacement in within Year 1.
2. Phase 2 – North, East & West Marina Point Wall (616 LF) replacement in Year 2.
3. Phase 3 – West Wall (181 LF) replacement in Year 3.

If the budget does not allow for completion of the entire project at one time, we recommend the phasing plan below based on completing the areas first in the worst condition.
